WELDING INSPECTION REPORT

Resident Engineer: Pursell, Gary **Report No:** WIR-015265 Address: 333 Burma Road **Date Inspected:** 02-Jul-2010

OSM Arrival Time: 700 **Project Name:** SAS Superstructure **OSM Departure Time:** 1900 **Prime Contractor:** American Bridge/Fluor Enterprises, a JV

Bridge No: 34-0006 **Component:** OBG

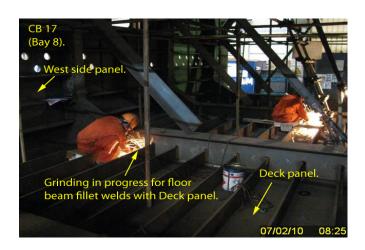
Repair welding of weld joint no: CB202C-014-003. Welding process was identified as Shielded Metal Arc Welding (SMAW). Welder is identified as 043661. ZPMC Quality Control (QC) is identified as Wang Liang. The welding variables recorded by QC appeared to comply with the Applicable WPS:

WPS-345-SMAW-4G(4F)-FCM-Repair (WRR No: B-WR-13787). Photo attached for reference.

Repair welding of weld joint no: FB205-043-035. Welding process was identified as SMAW. Welder is identified as 043661. ZPMC QC is identified as Wang Liang. The welding variables recorded by QC appeared to comply with the Applicable WPS: WPS-345-SMAW-4G(4F)-Repair-1 (WRR No: B-WR-13782 Rev-0). Photo attached for reference.
